DEPARTMENT OF NATURAL RESOURCES
DIVISION OF OIL, GAS AND MINING

RE: Site Inspection, Desert Lake Minerals and Emery Industrial Resources, Unpermitted WBF Quarry, S/015/091, Emery County, Utah

Date of Inspection: May 20, 2002
Time of Inspection: 12:00 to 3:00 p.m.
Conditions: Mostly cloudy, windy, 70's
Participants: Bonnie Wiese; Will Snyder, land owner; Val Payne, Emery County Public Lands Council; and Paul Baker, DOGM

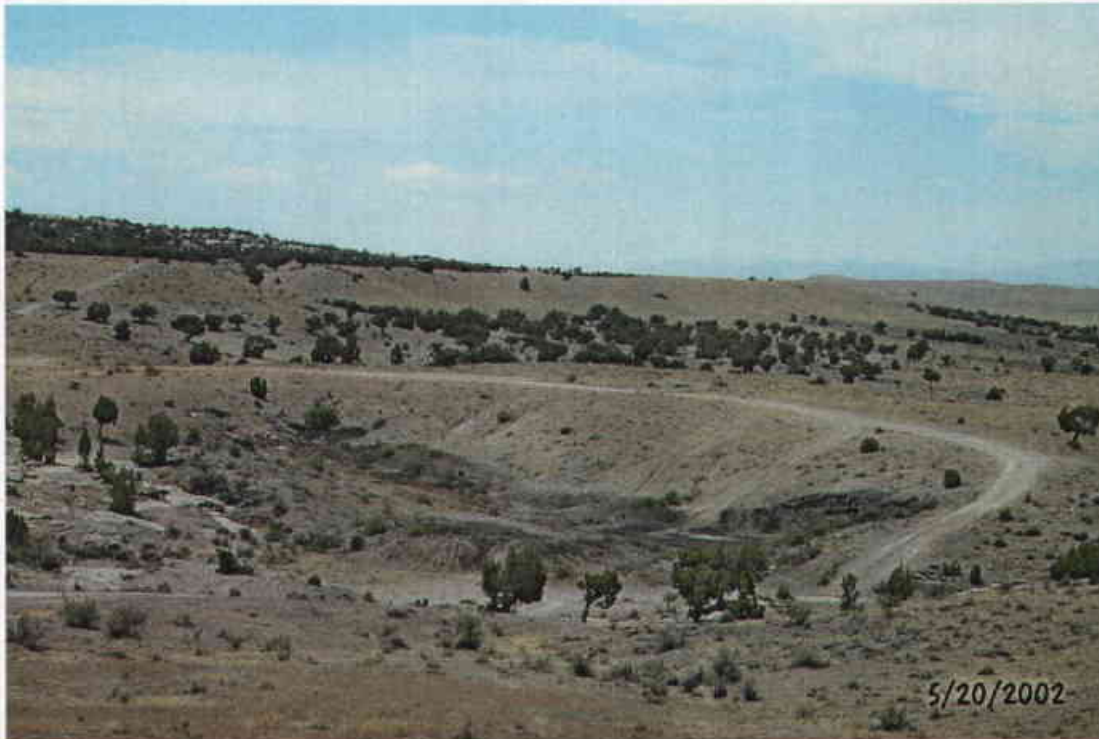
The site is on patented land in Section 24, Township 17 South, Range 10 East, SLBM. On the BLM 1:100,000 scale map, it is an odd-shaped piece surrounded by BLM land. As one travels east on the road leading to the Cleveland-Lloyd Dinosaur Quarry, there is a sign that says "Dip 15 mph." Shortly after this dip is another sign with the same warning, but before getting to the second dip, there is a road leading to the south. According to Mr. Payne, this is an RS 2477 road. Taking this road for a short distance, one comes to an intersection consisting of about three roads at the top of a hill. Going right from this intersection, the humic shale outcrop and disturbance are visible from the road (Photo 1). The road continues down the hill to the west then up a small draw to the disturbance site.

Photo 1. View of the disturbance area. The only area that appears to have been disturbed by recent mining activity is on the right side of the photo. The RS 2477 road goes across the ridge near the center of the photo.

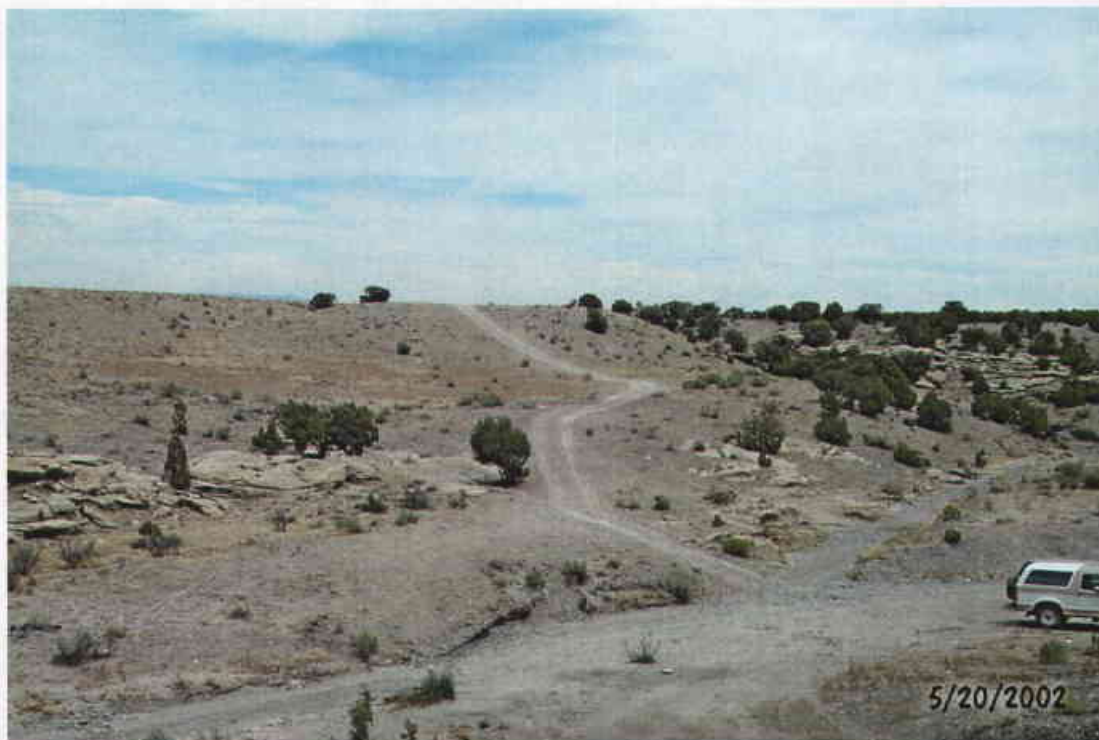
From the previously-mentioned intersection, the center road leads directly to the disturbance site (Photo 2), but this is not an RS 2477 road. It may have been built by those who were mining the area.

Photo 2. The main road comes up the draw from the lower left side of this photo. The road in the center of the photo is not an RS 2477 road and is not claimed by Emery county.

The operators may have disturbed more than the area shown in Photos 3 and 4, such as the road shown in Photo 2, but we are not certain of this. If it can be proven that this happened, the operators should also reclaim the road and any other disturbances they created.

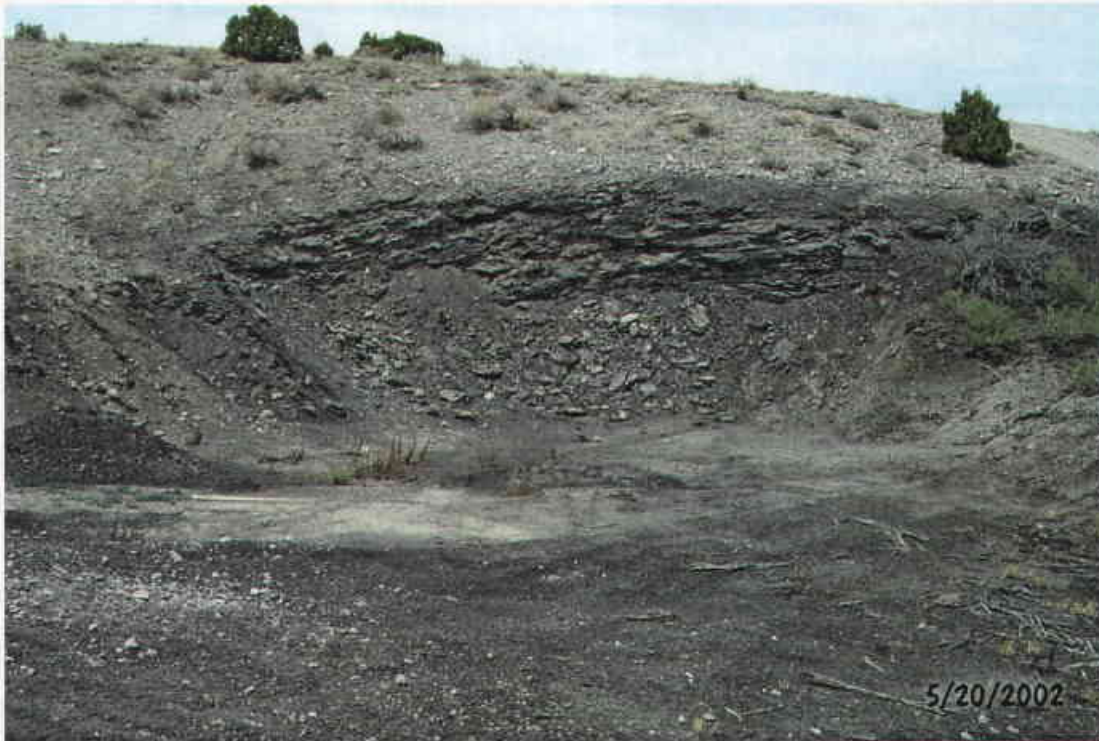
The area that appears to have been mined recently is shown in Photo 3. The disturbance area is about 40 feet in diameter or about 1250 square feet. There is an additional disturbed area, shown in Photo 4, that appears to have resulted from loading the material.

Photo 3. Out crop where it appears mining has occurred recently.

A letter of noncompliance should be sent to Desert Lake Minerals and Emery Industrial Resources. If these entities are able to reacquire the lease, they could be allowed to obtain a permit for a small mining operation. Otherwise, they need to reclaim their disturbance. Little if any grading would be necessary to reclaim the area, but it should be scarified and seeded.

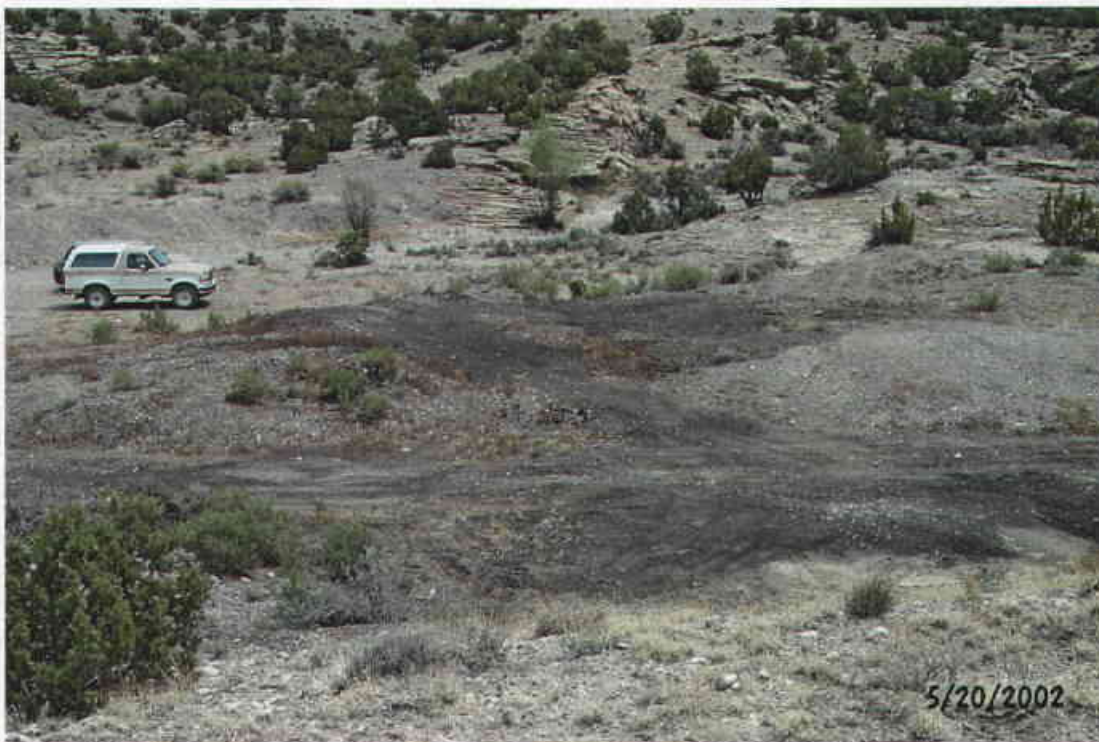
Photo 4. Area shown in Photo 3 (foreground) plus additional area that may have been used to load the material (center of photo).

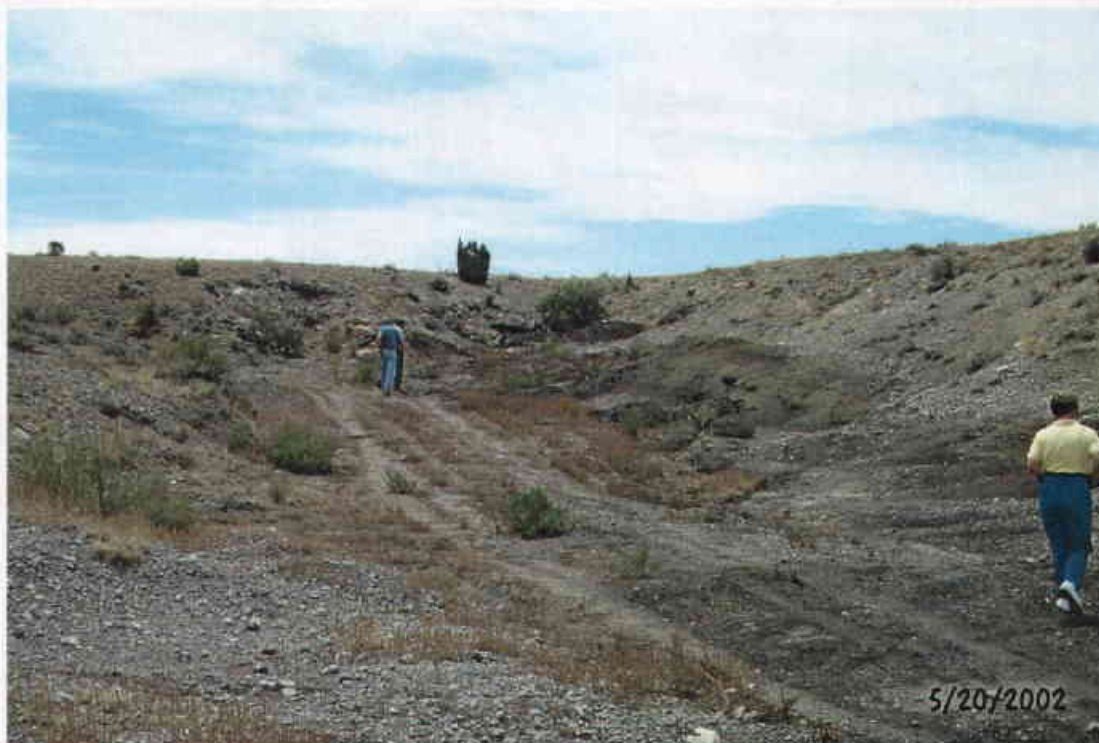
Photo 5 is an area just up from the area in Photo 3. An exploration hole can be seen near the center of this photo, but based on the vegetation next to the hole, we do not believe this was dug recently.

Photo 5. Looking uphill from the area of Photo 3. At the top of this draw and just above the center of the photo there is what appears to be an old exploration hole.

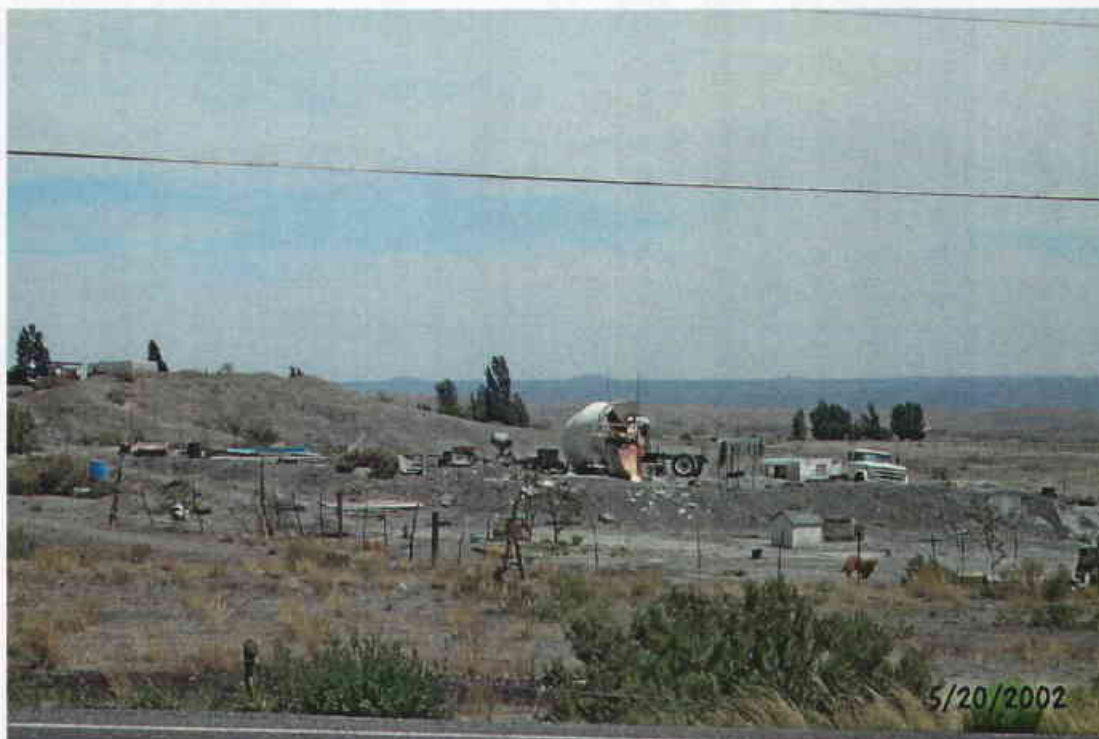
Mr. Snyder indicated the mined material was taken to a processing facility adjacent to the home of Gerald Powell just south of Huntington (Photo 6). The processing apparently consisted of crushing and mixing the material. Mr. Snyder provided copies of invoices indicating 120 tons was sold to a farmer.

Photo 6. Processing facility south of Huntington.
